# Approved Vehicle Dealer Inspection Report

**PARADISE  
MOTORS**

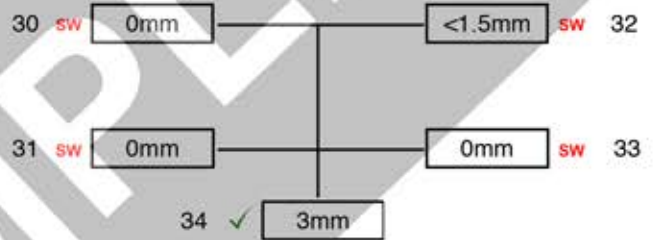
**Tyre tread depth**

- 28 ✓ Wheel/tyre size and condition (ADR's)
- 29 ✓ Jack / tools and accessories
- 30 **SW** Pass. Side Front Tread Depth
- 31 **SW** Pass. Side Rear Tread Depth
- 32 **SW** Driv. Side Front Tread Depth
- 33 **SW** Driv. Side Rear Tread Depth
- 34 ✓ Spare Tread Depth

Item	Image ref	Component	Comment
63	<b>EW</b>	Central Locking Remote Door Locks / Keys	Remote not working
14	<b>SW</b>	Eye/High level stop light (COPY) Stop Light	Inoperative light
30	<b>SW</b>	Tread	Depth below legal minimum
31	<b>SW</b>	Tread	Depth below legal minimum
32	<b>SW</b>	Tread	Depth below legal minimum
33	<b>SW</b>	Tread	Depth below legal minimum

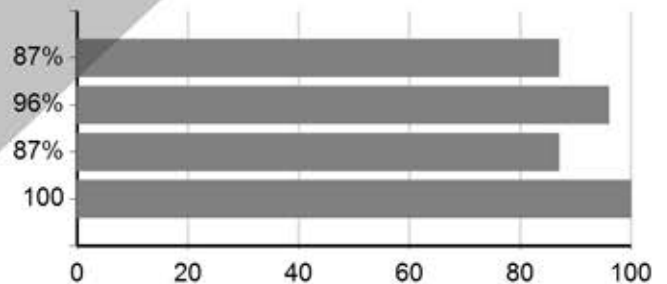
**Engine cylinder performance test**

Cylinder variance 13

Relative compression testing combined with visual symptoms of oil fuming, coolant rise, defect codes and road test performance is used to determine engine cylinder performance. Relative compression testing does not identify individual cylinder compression and is purely a test to indicate potential variances. Engine cylinder performance testing does not detect oil burning, leaking head gaskets, the presence of induction air leaks or emission control device faults that affect engine performance. If variances or visual symptoms are identified during the evaluation it may be indicative of an engine performance problem and we recommend further engine testing such as direct compression testing. We are unable to perform relative engine compression testing on some Hybrid vehicles.

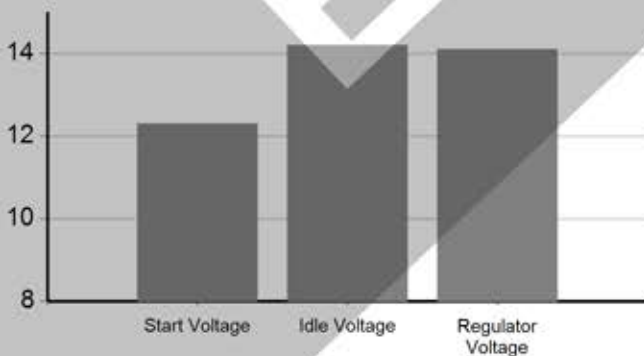
**Battery voltage**

Average battery cranking voltage 10.84
